Revival of an Icon

The United Nations renovation team brings back the long-faded luster of the Secretariat while satisfying ambitious performance goals.

By Joann Gonchar, AIA

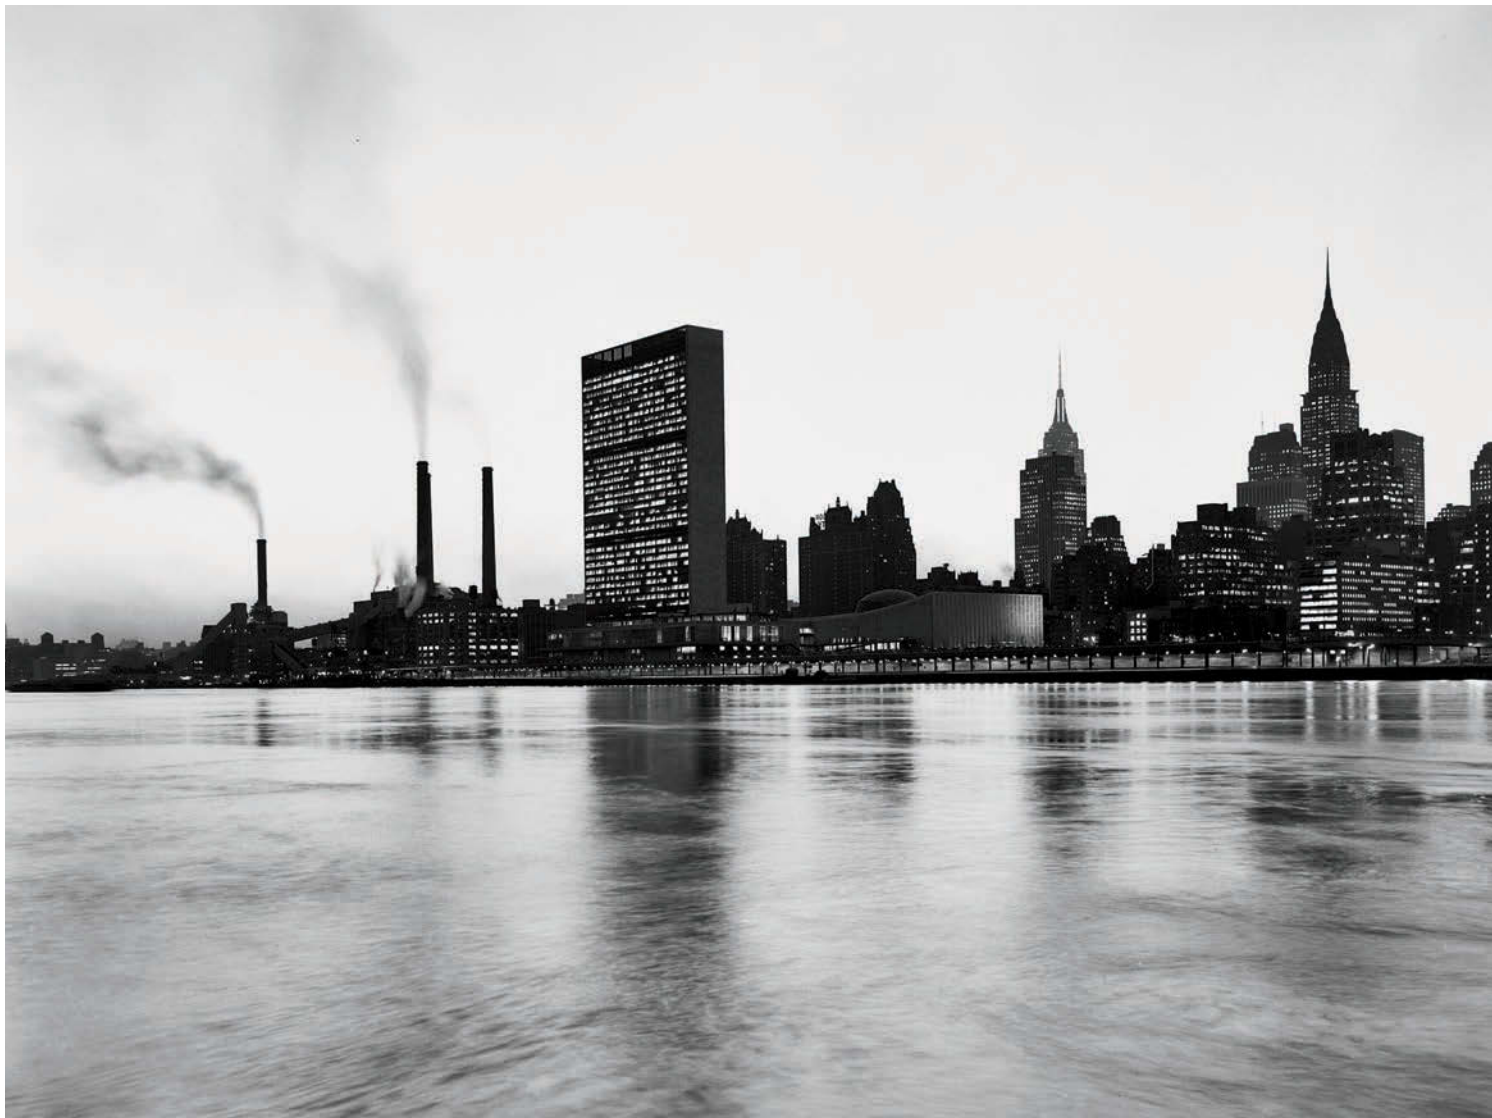
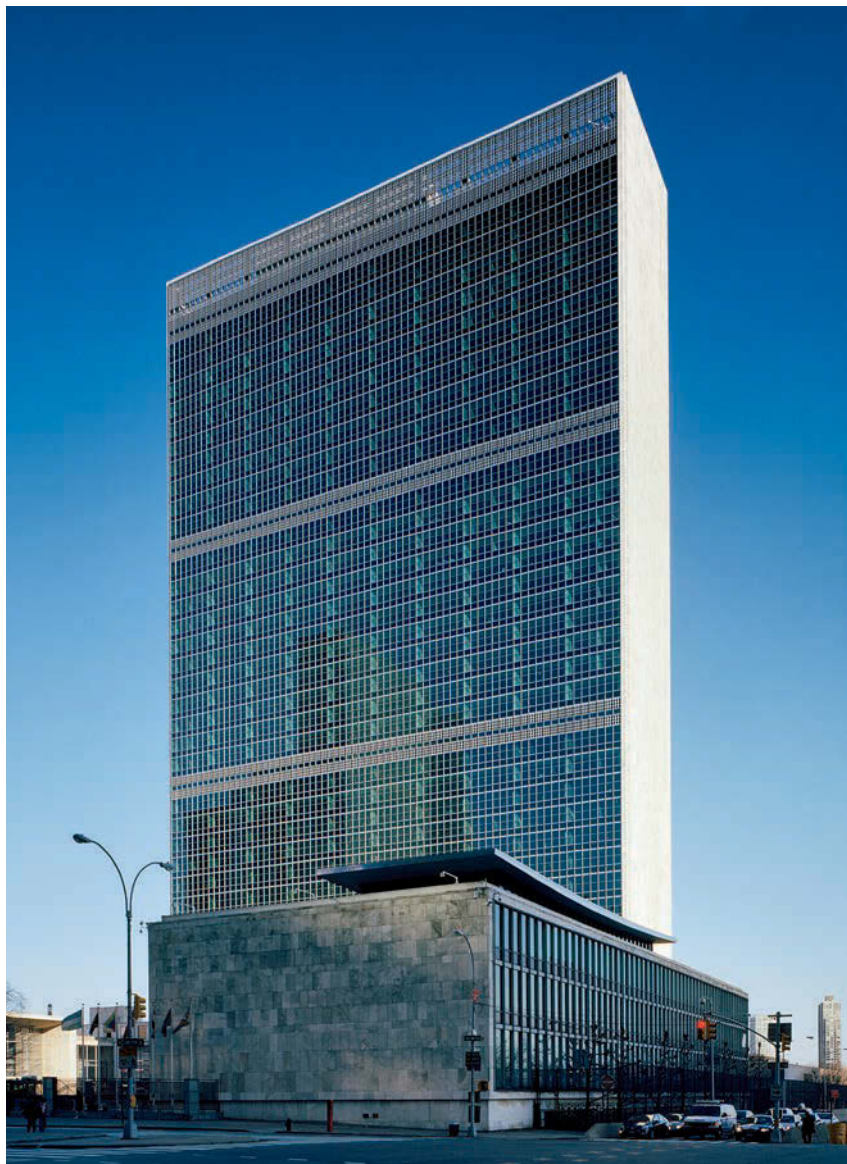
CENTERPIECE
The strikingly thin, 39-story Secretariat was the most prominent piece of the United Nations compound in the early 1950s (above), as it is today.

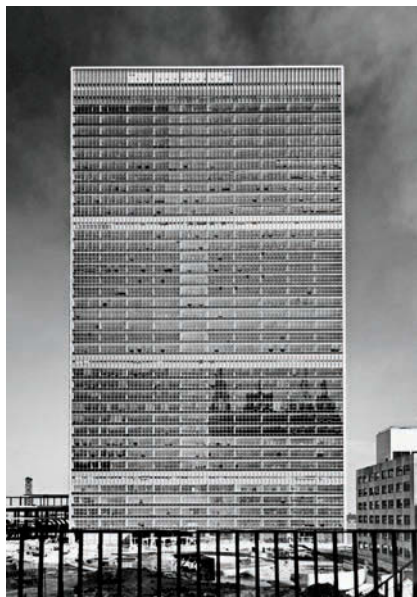
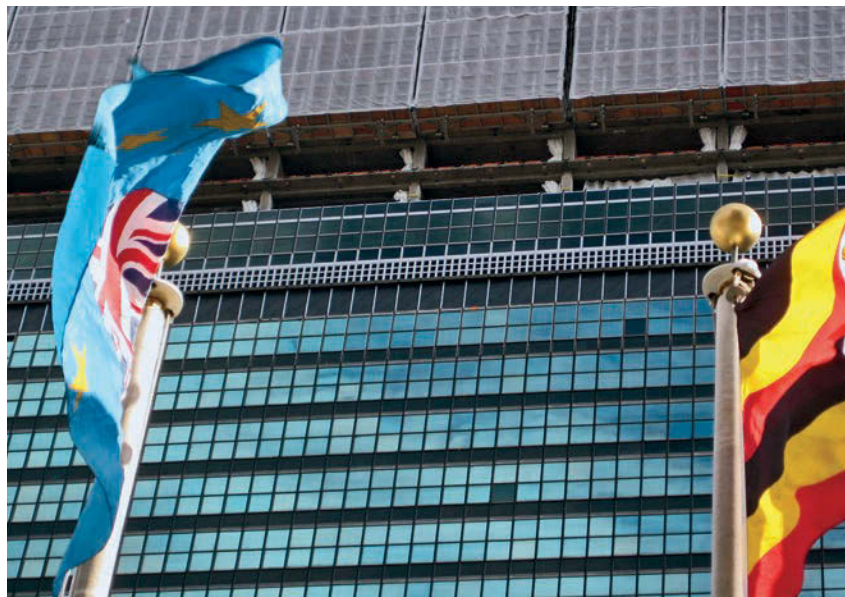
FIRST BUT FLAWED
The Secretariat is the first skyscraper with a curtain-wall skin. However, the transparency of its original glazing (far left) was compromised by the installation of reflective film on both the east and west (near left) facades. The new curtain wall (above) re-creates the appearance of the building during the years just after completion, but with a state-of-the-art pressure-equalized system.

The glare and heat-gain problems were most acute on the building's east side, which faces the East River. Here, almost immediately after the building's opening, the U.N. installed a reflective film to the inside of the vision glass. (A different type of adhesive film was applied to the Secretariat's west facade—which is partially shaded by Midtown Manhattan's mass of buildings—but not until after the 9/11 attacks in response to heightened security concerns.) The east facade's reflective film helped reduce the solar load, but it also radically altered the Secretariat's appearance, eventually bubbling, wrinkling, and peeling. And because the glazing was simply annealed (meaning it had not been heat-treated), the film also induced thermal stresses, causing the glass to

break. As the panels cracked, they were replaced with glazing of various types, creating a jumble of different hues and degrees of transparency.

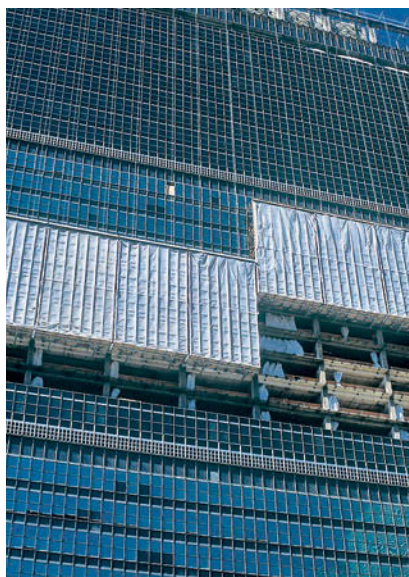
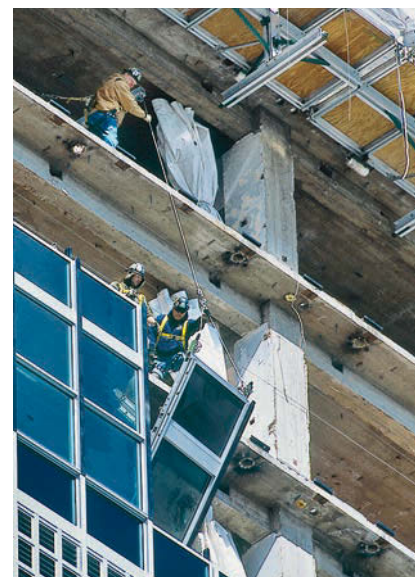
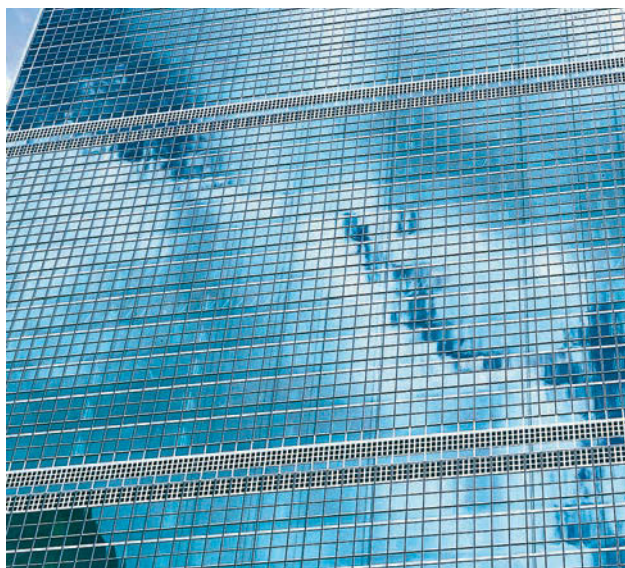
SEQUENCE

Demolition of the original curtain wall (above left) and installation of the new one (above right) proceeded from bottom to top in each of the roughly 10-story zones defined by the tower's louvered mechanical levels. The new cladding (left) incorporates numerous performance enhancements, including a low-E coating and blast resistance.

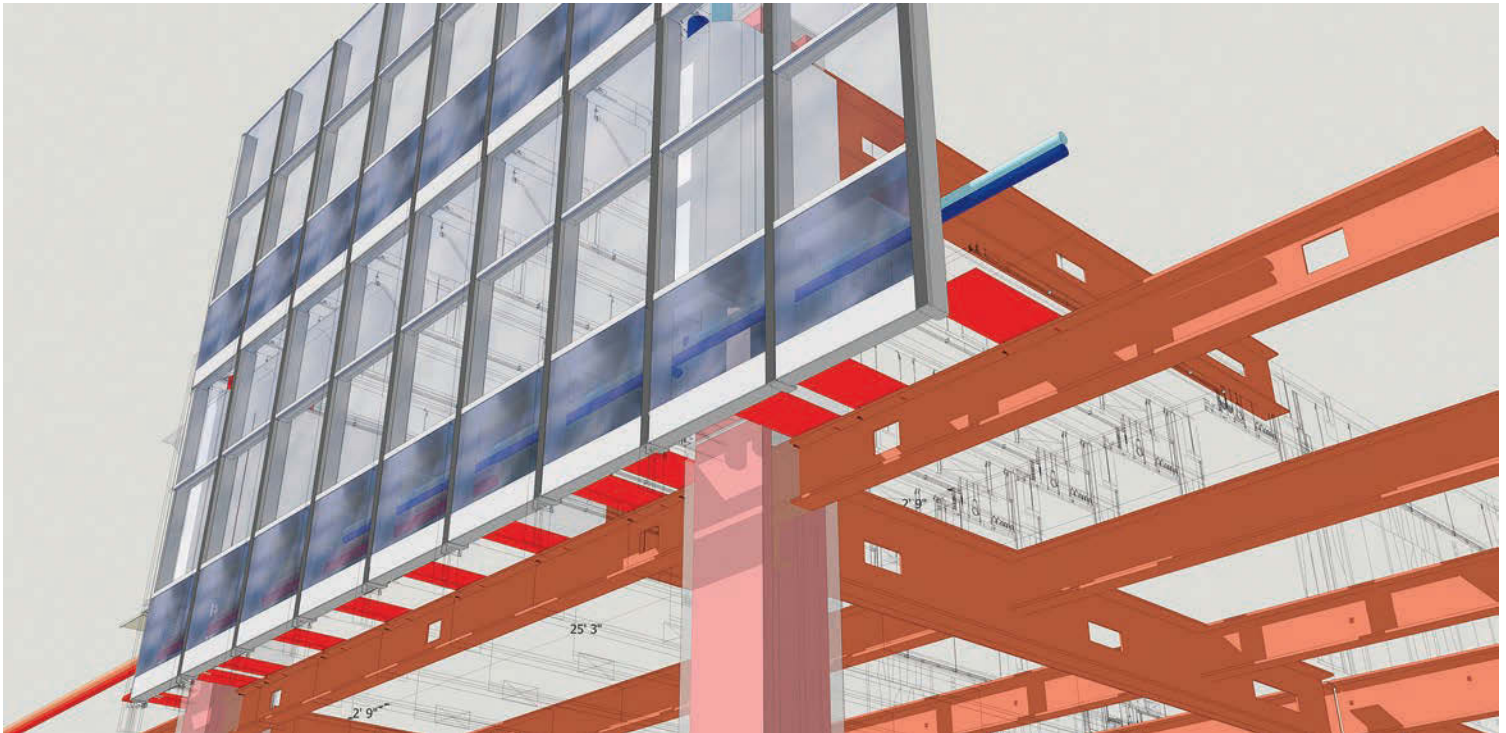
NEW AND IMPROVED

Although the Secretariat's original curtain wall was anchored to the concrete floor slabs, the new curtain wall (above) is tied to the building's moment-frame structure with outrigger plates. As part of the curtain-wall replacement, the masonry knee walls at the spandrels, mandated by now-outmoded fire codes, have been eliminated.

Due to security concerns, the U.N.'s consultants won't reveal all the details of the new curtain wall. However, they describe it as unitized, pressure-equalized, and thermally broken. Although the original had been anchored to the floor slabs, outrigger plates now tie the assembly to the building's frame, which has also been made more robust.

The profiles of the curtain wall's aluminum extrusions closely follow those of the original components, but project a few inches farther into the building's interior in order to accommodate the performance enhancements. Although all of the glazing is fixed, some extrusions are offset to mimic the appearance of the original double-hung windows. Designers decided against similarly offsetting the glazing to replicate upper and lower sashes because computer simulation showed that doing so would produce an almost imperceptible effect.

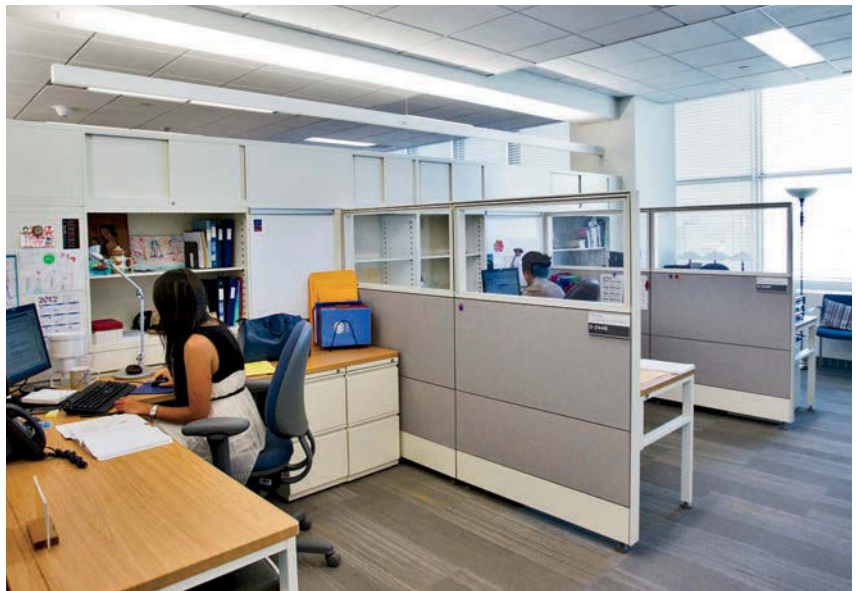
MODULAR AND FLEXIBLE To facilitate future changes to office floor layouts, the Secretariat renovation team has created an open-plan system organized around 78-inch-tall furniture-like "work walls" that extend from each perimeter column and contain power, data, and storage.

Many more U.N. employees should be able to enjoy the daylight and views afforded by the new curtain wall, since the interior has been transformed from a warren of mostly private offices to floors devoted almost entirely to open and reconfigurable workspaces. These spaces are organized by 78-inch-tall modular "work walls" that extend from the perimeter columns and contain shelving, power, and data. The new Secretariat office floor layout also has a clearly defined circulation path around the perimeter of the core—a feature that was inexplicably lacking in the original building. "Way-finding was a nightmare," according to HLW's Gering. The ceiling in this new zone is 8 feet tall, gradually stepping up to 9 feet 6 inches at the windows, creating a configuration that reinforces the circulation path and aids in the distribution of mechanical services.

Each employee will have an average of 170 square feet of workspace, a number that is down from a pre-renovation average of 193 square feet. The figure includes new shared amenities such as "focus rooms" for sensitive phone calls or tasks requiring intense concentration; pantries; and spaces for small and impromptu meetings, distributed throughout the floor. More formal conference facilities, which are greatly expanded in the renovated Secretariat, and whose area is not part of the individual workspace totals, have been moved to dedicated floors below each mechanical level.
