Application notes

Ericsson / MediaKind RX8200

Upgrade to FW version 8.25.1

Version 1.1 (July 2020)

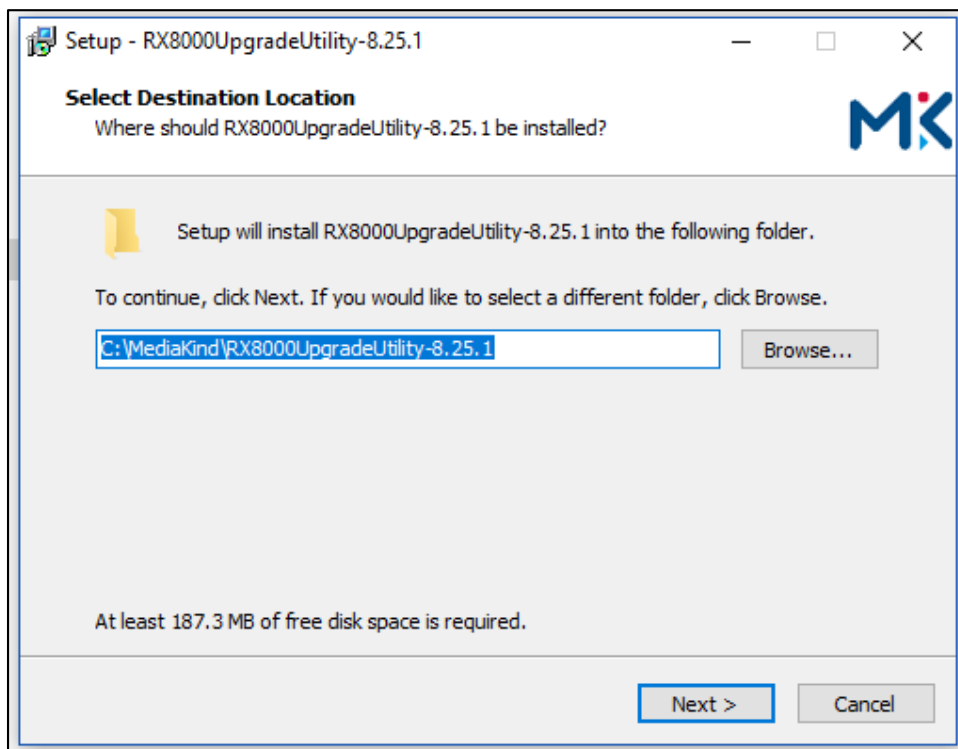
- Set up the target installation folder then click **Next**.

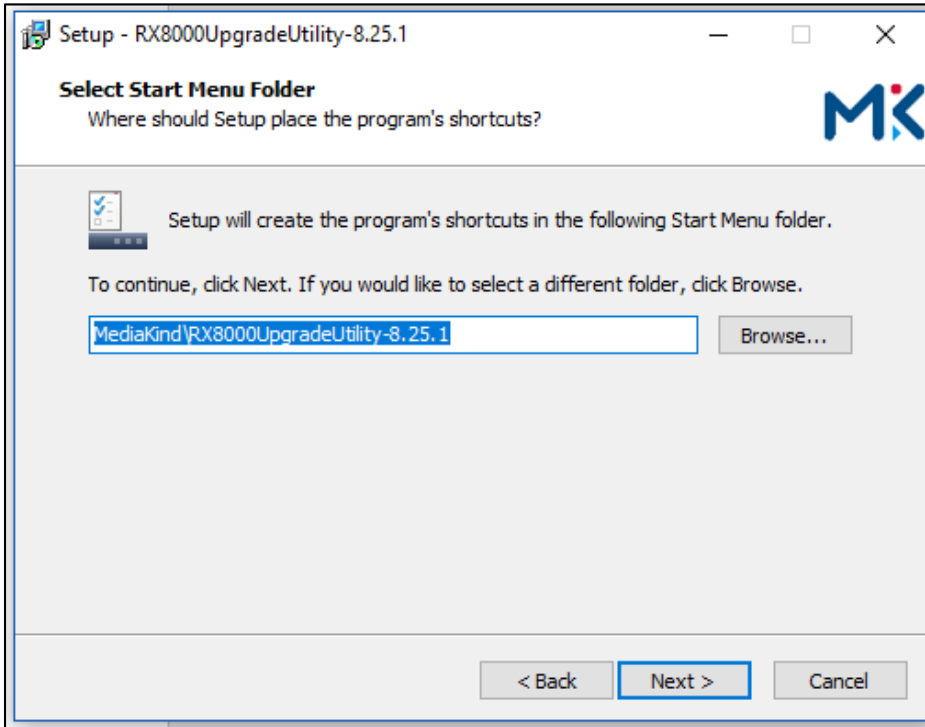
- Set up the shortcut path for the start menu folder then click **Next**.

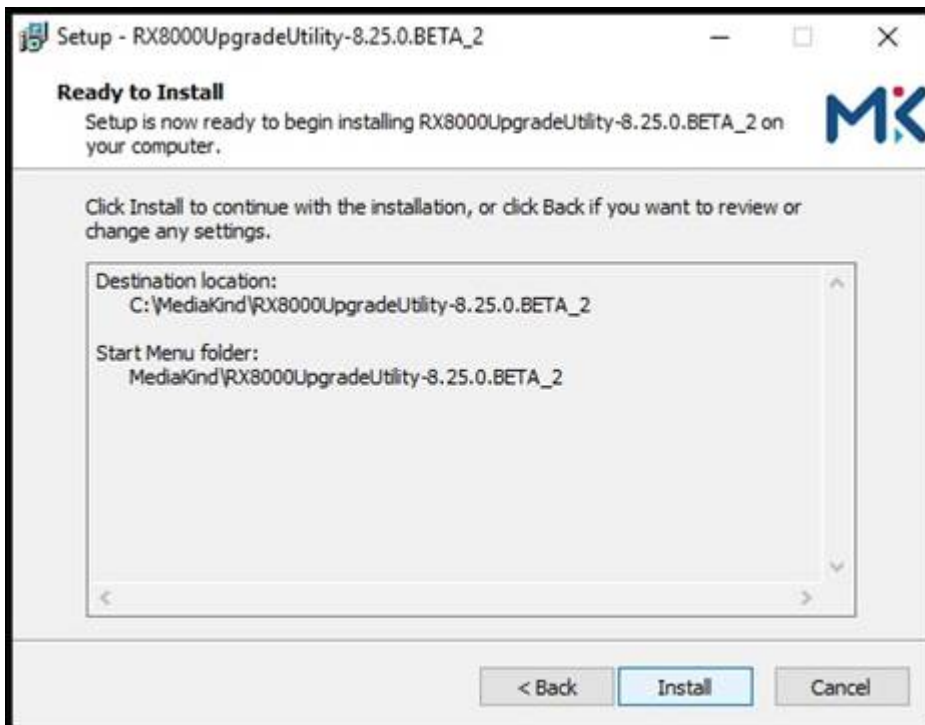
- When you are ready to proceed with the installation, click **Install**.

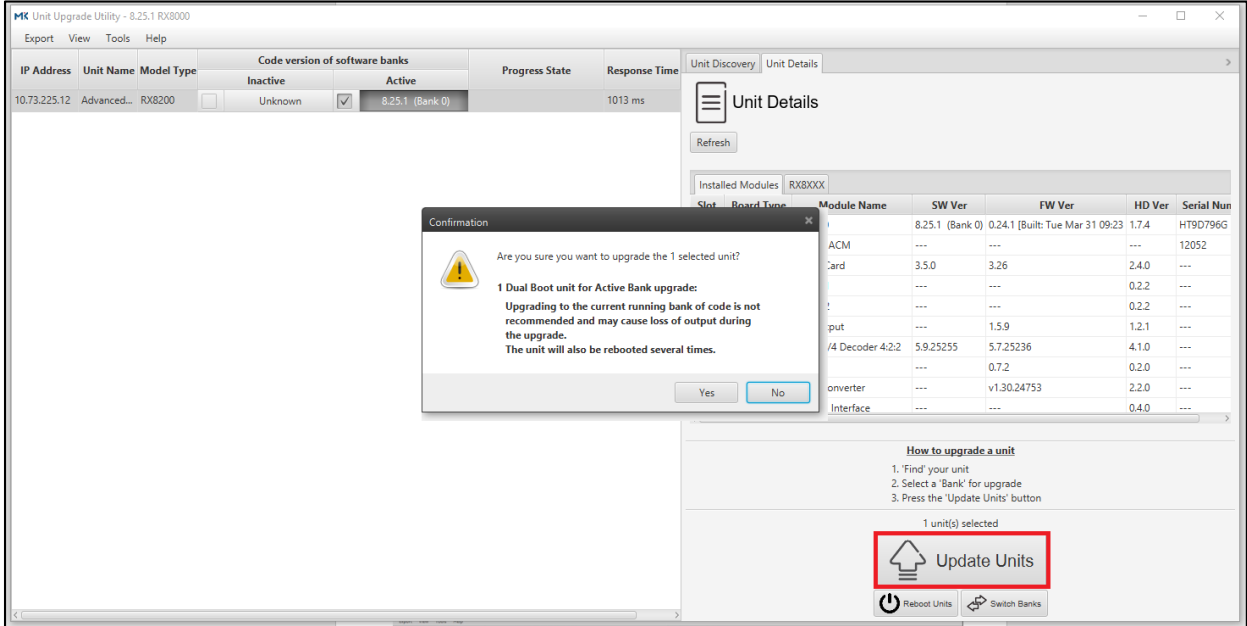
3.2.3.3 STEP 3 - Upgrade Units

Click the **Update Units** button at the bottom right-hand side of the upgrade utility. When a device is selected for upgrade, the wizard determines what cards are installed on the device and upgrades all cards to the versions contained in the distribution package.

Note: The upgrade utility does not allow the user to pick and choose which modules to upgrade. All fitted modules will be upgraded.

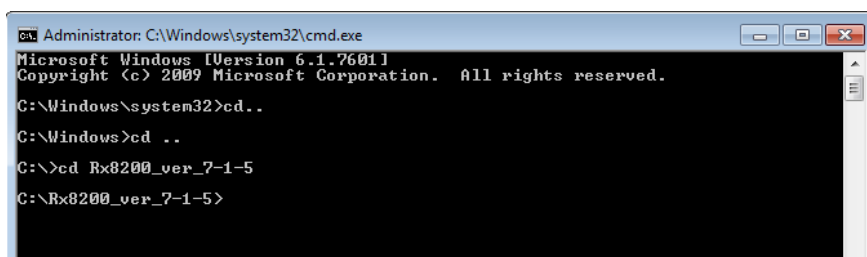
Go to the folder where *RX8200_ver_7-1-5* was downloaded to.

C:\Windows\system32>cd ..
C:\Windows>cd ..
C:\>cd RX8200_ver_7-1-5
C:\RX8200_ver_7-1-5>

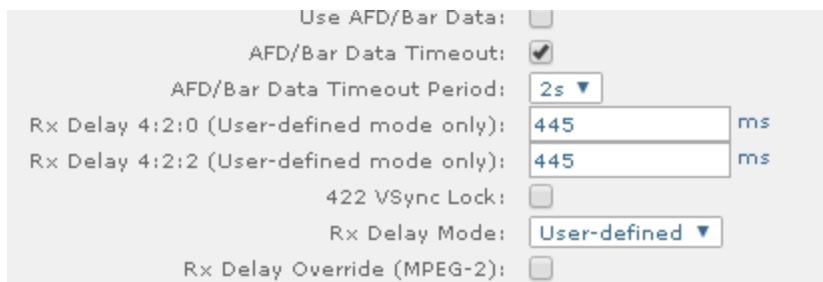
Under **Decode > Advanced**, please check the “**Rx delay mode**”, and set it to the values shown below:

AFD/Bar Data Timeout Period: 2s

Rx Delay 4:2:0 (User-defined mode only): 445 ms

Rx Delay 4:2:2 (User-defined mode only): 445 ms

Rx Delay Mode: User-defined

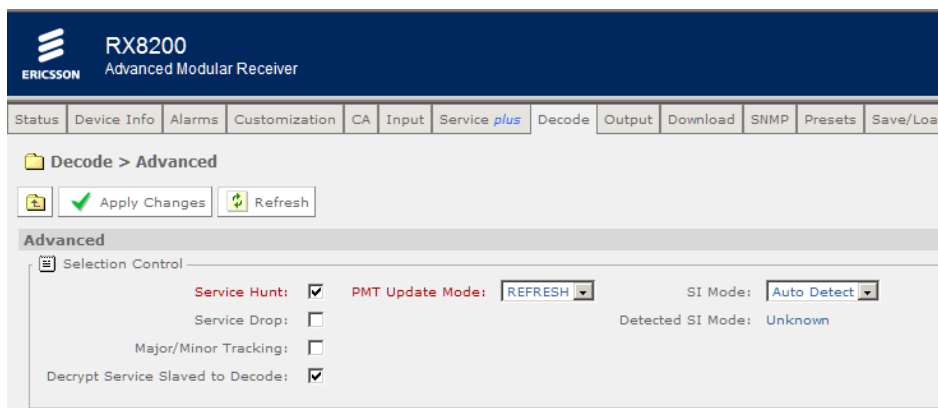
Also check the **PMT update mode** is set to “**Refresh**”.

Service Hunt: PMT Update Mode: REFRESH SI Mode: Auto Detect

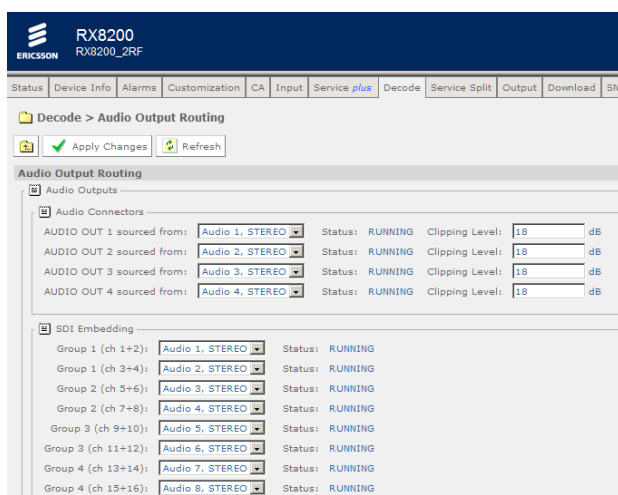
Under **Decode > Audio Output Routing**, please check that all the audio pairs are correctly embedded in the SDI signal and that “clipping level” for all channels is set to **18dB**:

AUDIO OUT 1 sourced from:	Audio 1, STEREO	Status:	RUNNING	Clipping Level:	18 dB
AUDIO OUT 2 sourced from:	Audio 2, STEREO	Status:	RUNNING	Clipping Level:	18 dB
AUDIO OUT 3 sourced from:	Audio 3, STEREO	Status:	RUNNING	Clipping Level:	18 dB
AUDIO OUT 4 sourced from:	Audio 4, STEREO	Status:	RUNNING	Clipping Level:	18 dB

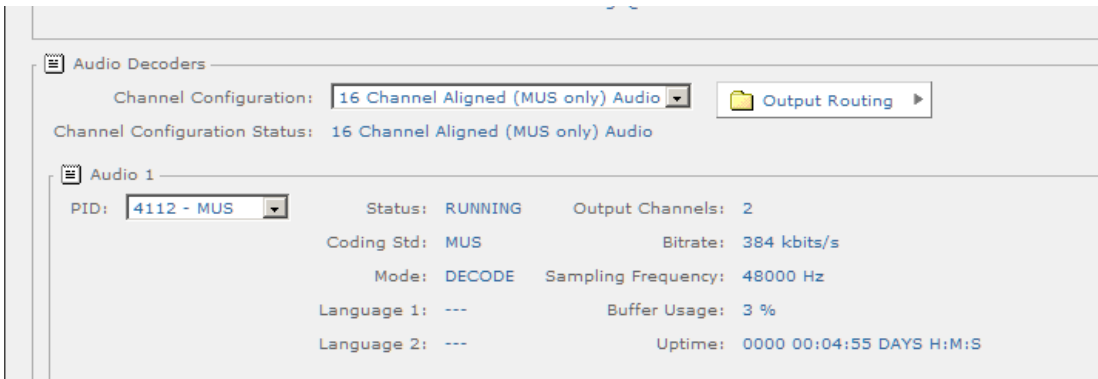
In order to have 16 phased aligned audio channels, select the option: “**16 Channel Aligned (MUS only) Audio**”:
